# The geomorphological response of uplifted unconsolidated coastal environments, Kaikōura, New Zealand

A thesis submitted in partial fulfilment of the  
requirements for the degree of  
**Master of Science in Environmental Science**  
at the University of Canterbury

**Kate MacDonald**  
University of Canterbury  
February 2019

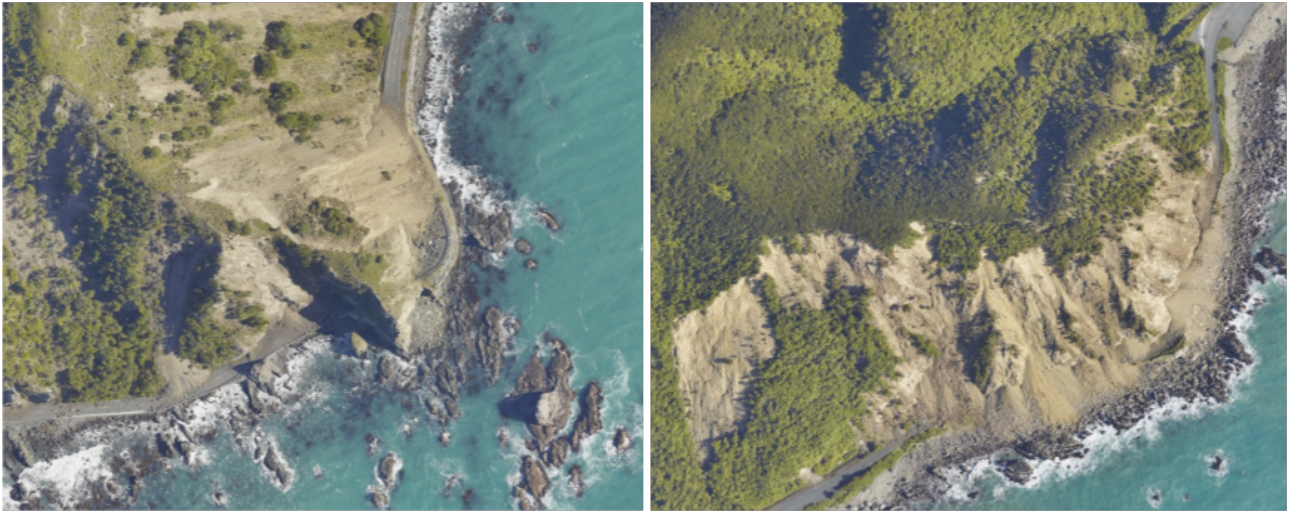
**Figure 3.7:** Two of the estimated >10,000 landslides which occurred as a result of the 7.8 Kaikōura Earthquake. The left image shows a landslide which was located approximately 10 km south of the Peninsula. The landslide at Ohau Point (right), is located approximately 25 km north of the Peninsula. Seawalls have now been put at both locations to protect the recovery efforts from intense wave action. Images sourced from the LINZ Data Service.

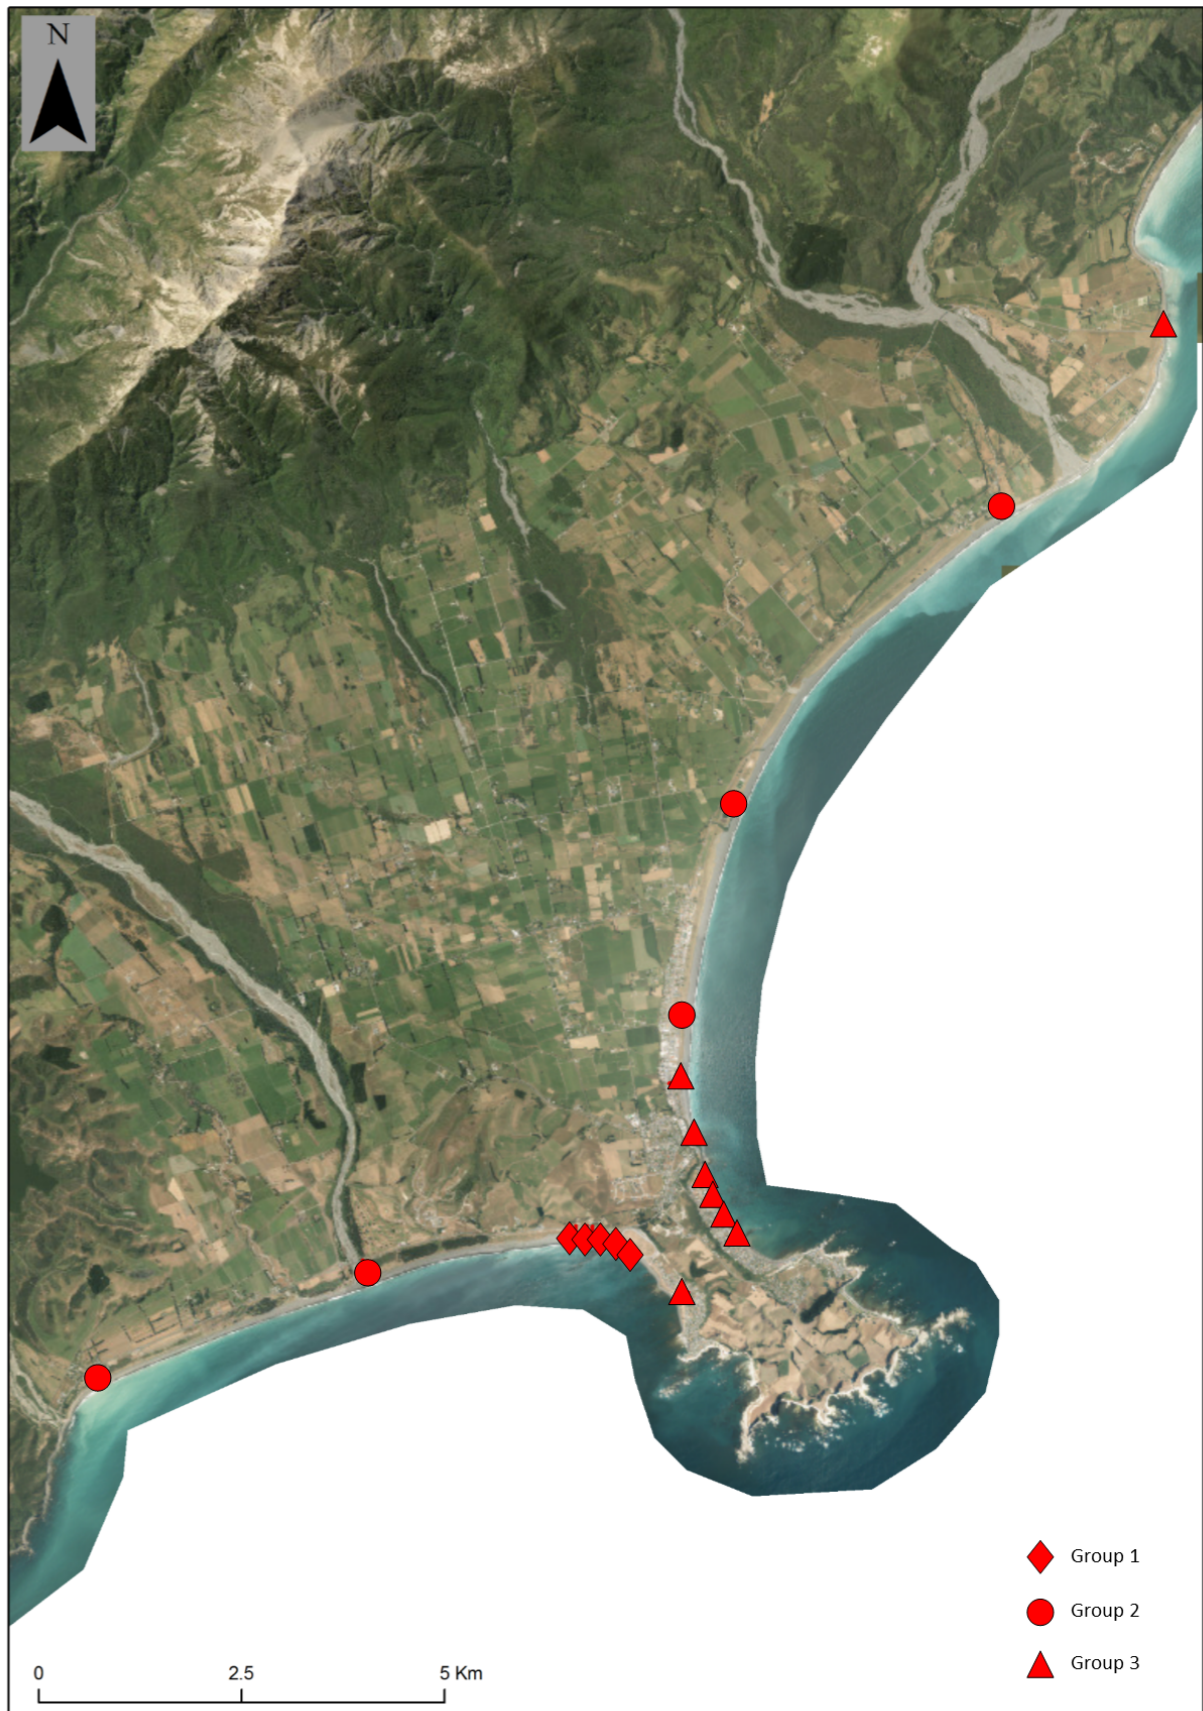
**Figure 5.3:** Distribution of groups based on the cluster analysis using geomorphic parameters. The cluster analysis results showed that there were 3 main variations of MSG beaches found in the study area, and they are predominantly distributed in geographically similar areas with common environmental conditions acting on the profiles. Basemap sourced from the LINZ Data Service.

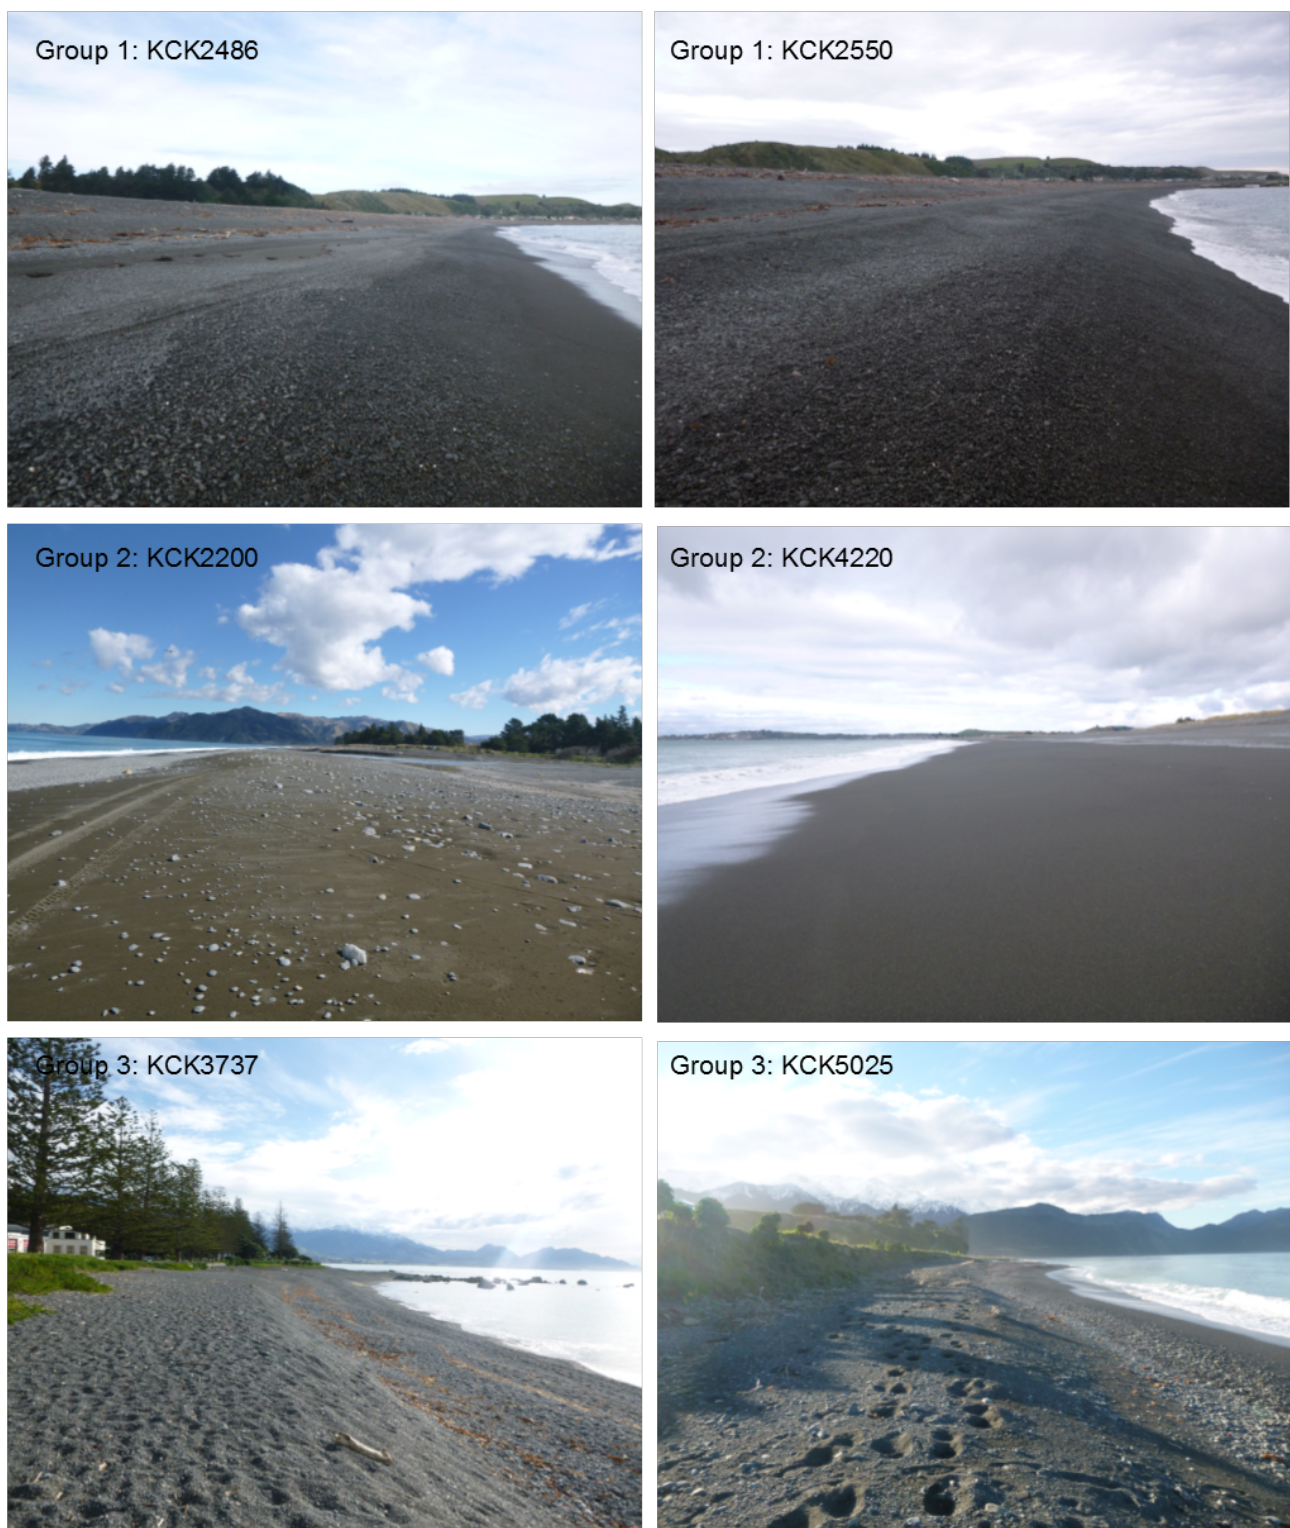
**Figure 5.4:** Images taken August 2018 of the three different beach groups: (Top) Group 1 accretionary South Bay beaches, taken at KCK2486 and KCK2550; (middle) Group 2 wide and flat open coast and rivermouth beaches, taken at KCK2200 by the Kowhai rivermouth and KCK4220 by the oxidation ponds; and (bottom) Group 3 steep and narrow beaches, taken at KCK3737 and KCK5025. Photo credit: K MacDonald

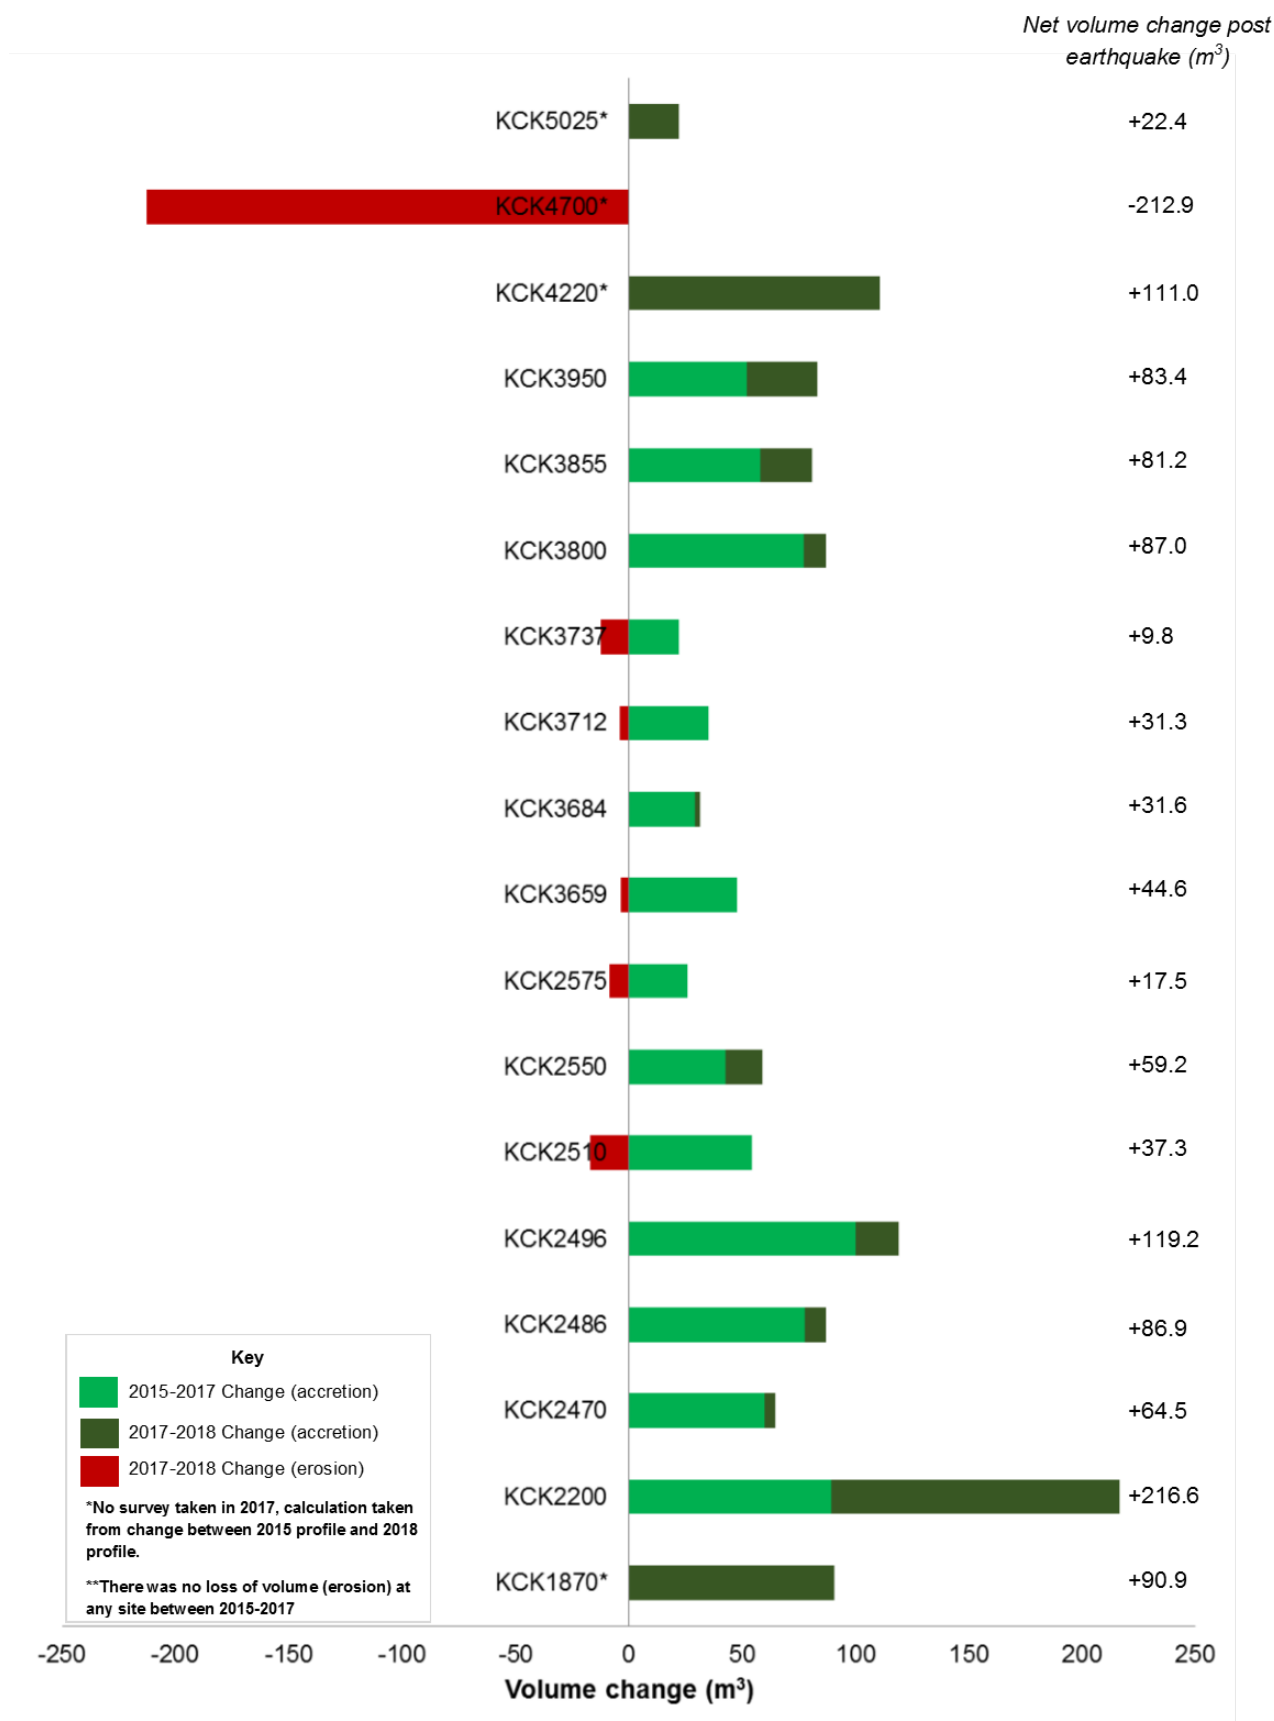
**Figure 7.4:** Summary of post-earthquake volume changes between each survey following the earthquake. All profiles surveyed in 2017 experienced an increase in subaerial volume. The 2018 survey showed some profiles had begun to erode, but profiles still maintained an overall net gain of subaerial sediment volume. Profile KCK4700 was not surveyed in 2017, however the overall volume change from 2015-2018 shows a significant loss of subaerial volume. This profile also experienced no uplift. No profiles showed volume loss between 2015-2017.
